TECH TIPS

CONCENTRIC SLAVE CYLINDERS

COMMON CSC FITMENT PROBLEMS

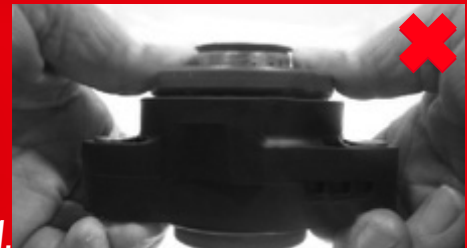
1.

- **NEVER** depress the slave cylinder by hand prior to fitting! (image 1)
 - This may result in the seals being dislodged (image 2) or torn and cause the CSC to leak once installed, and potentially contaminate the clutch disc with fluid.
- **BE CAREFUL** when tightening plastic CSC tubes!
 - Too much force can cause plastic CSC tubes to break.

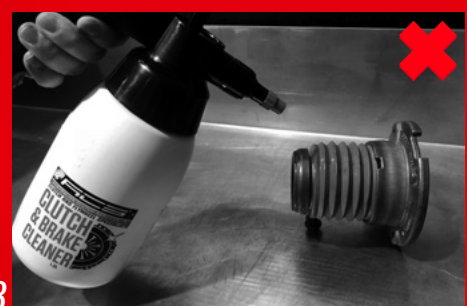
3.

- **DO NOT** spray brake cleaner or solvents in or around the CSC! (image 3)
 - This can cause the seals to swell and wash away the assembly oil.

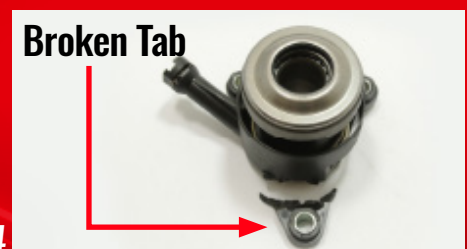
4.

- When mounting a CSC care must be taken that it seats correctly on the gearbox and is not mounted off axis.
- All mounting surfaces must be clean and free of dirt and contaminants.
- Correct bolt torque must be used to prevent damage to the CSC.
 - Failure to follow the correct mounting procedures can lead to CSC damage (image 4), leaking and a staging pedal.

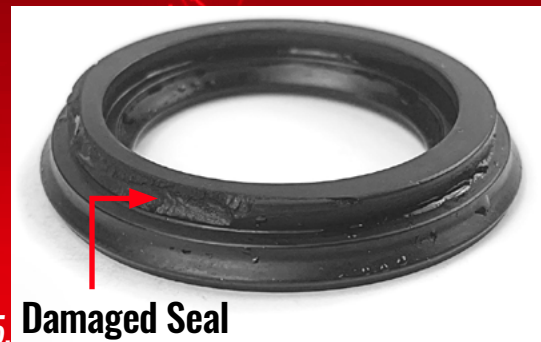
- If a piston is over stroked, it can cause damage to the end of the guide tube or even to the piston seals. (image 5)
- Over stroking can be caused by several things such as:
 - Incorrect pedal adjustment.
 - Incorrect clutch fitment causing a low installed height.

5. Damaged Seal

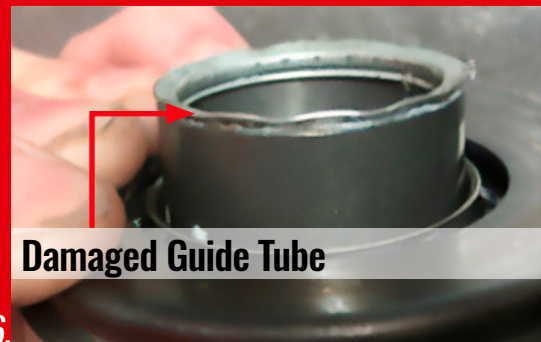
6.

- If a clutch disc is fitted incorrectly (back to front), it can cause damage to the end of the guide tube and is likely to cause a release problem and permanently damage the slave and/or the disc (image 6).

Damaged Guide Tube

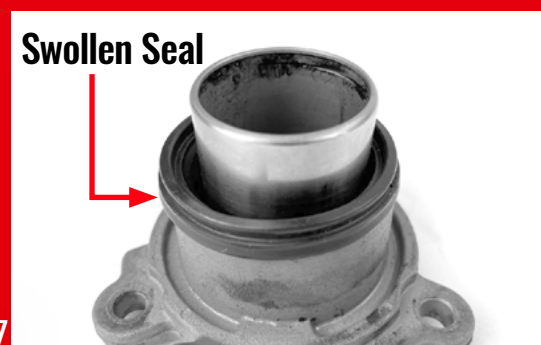
7.

- When installing a new CSC the fluid system should be flushed in order to remove any dirt and contaminants.
- Failure to do so can potentially damage the seals and cause the CSC to leak or fail, voiding any warranty.
- Contaminated fluid can cause swelling of the rubber seals. (image 7)

Swollen Seal
